# ConocoPhillips Mississippi River Pipeline Release

August 6 - October 3, 2003

presented by Tim Ganz, former State On-Scene Coordinator,  
Missouri Department of Natural Resources  
Environmental Emergency Response Section

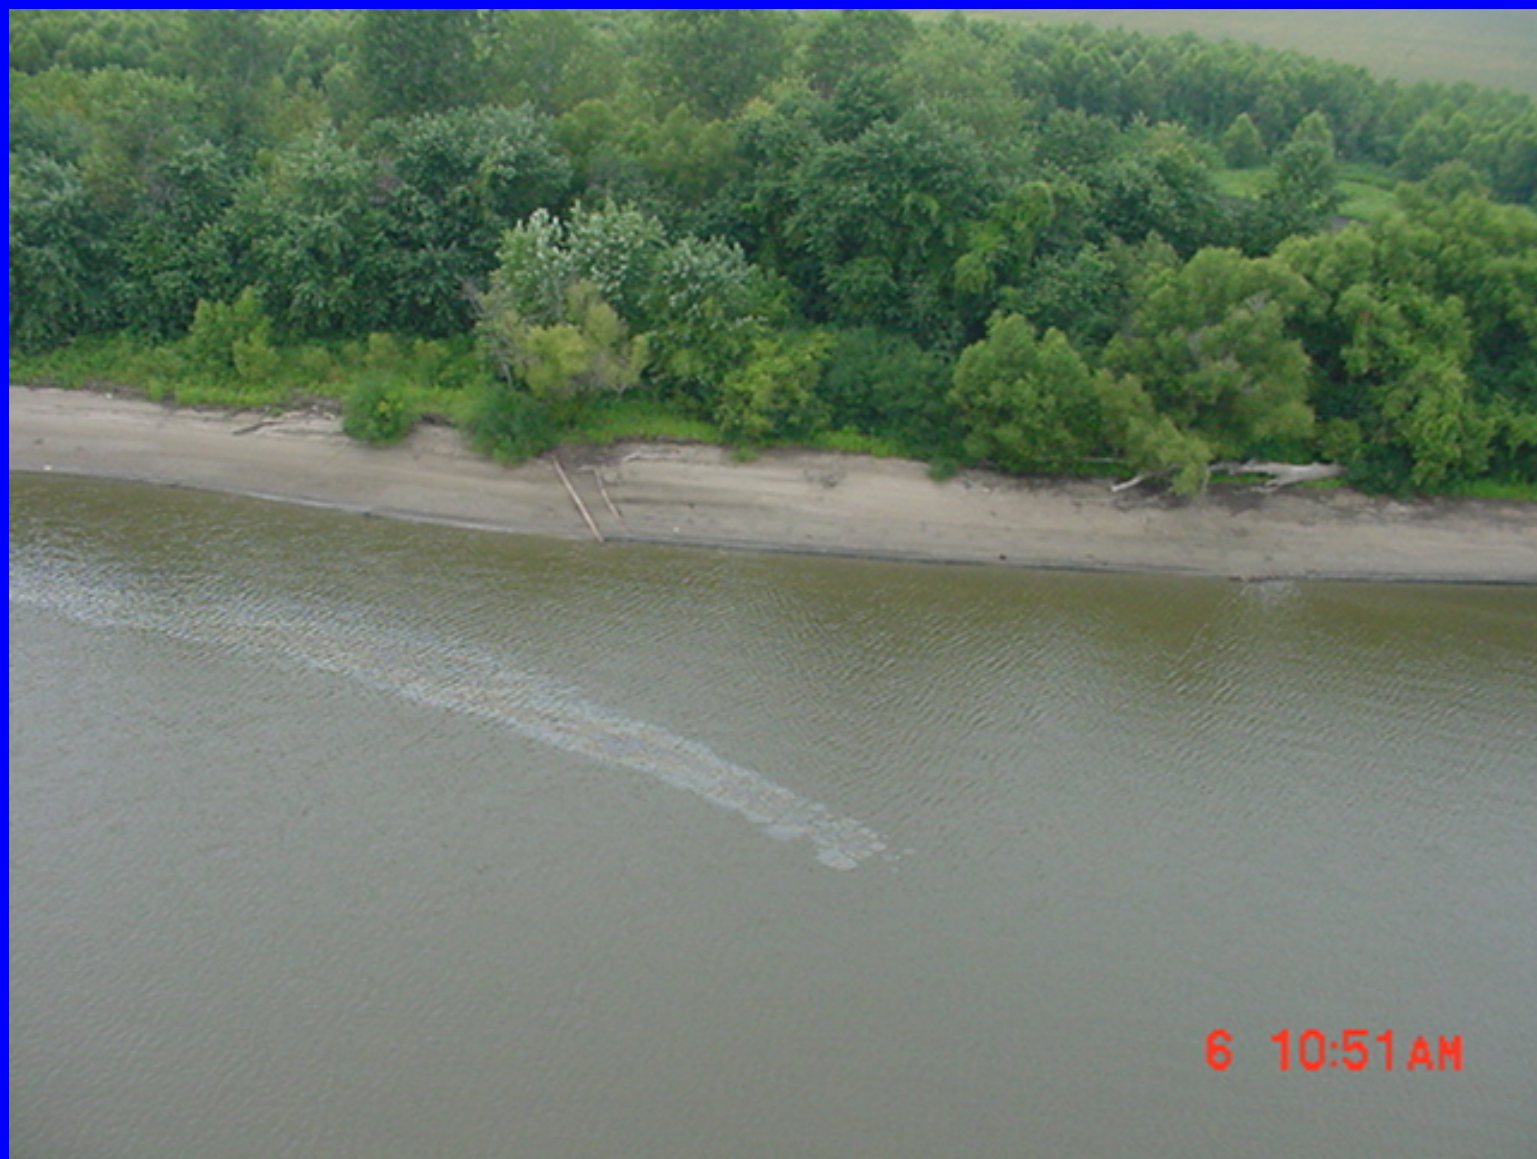
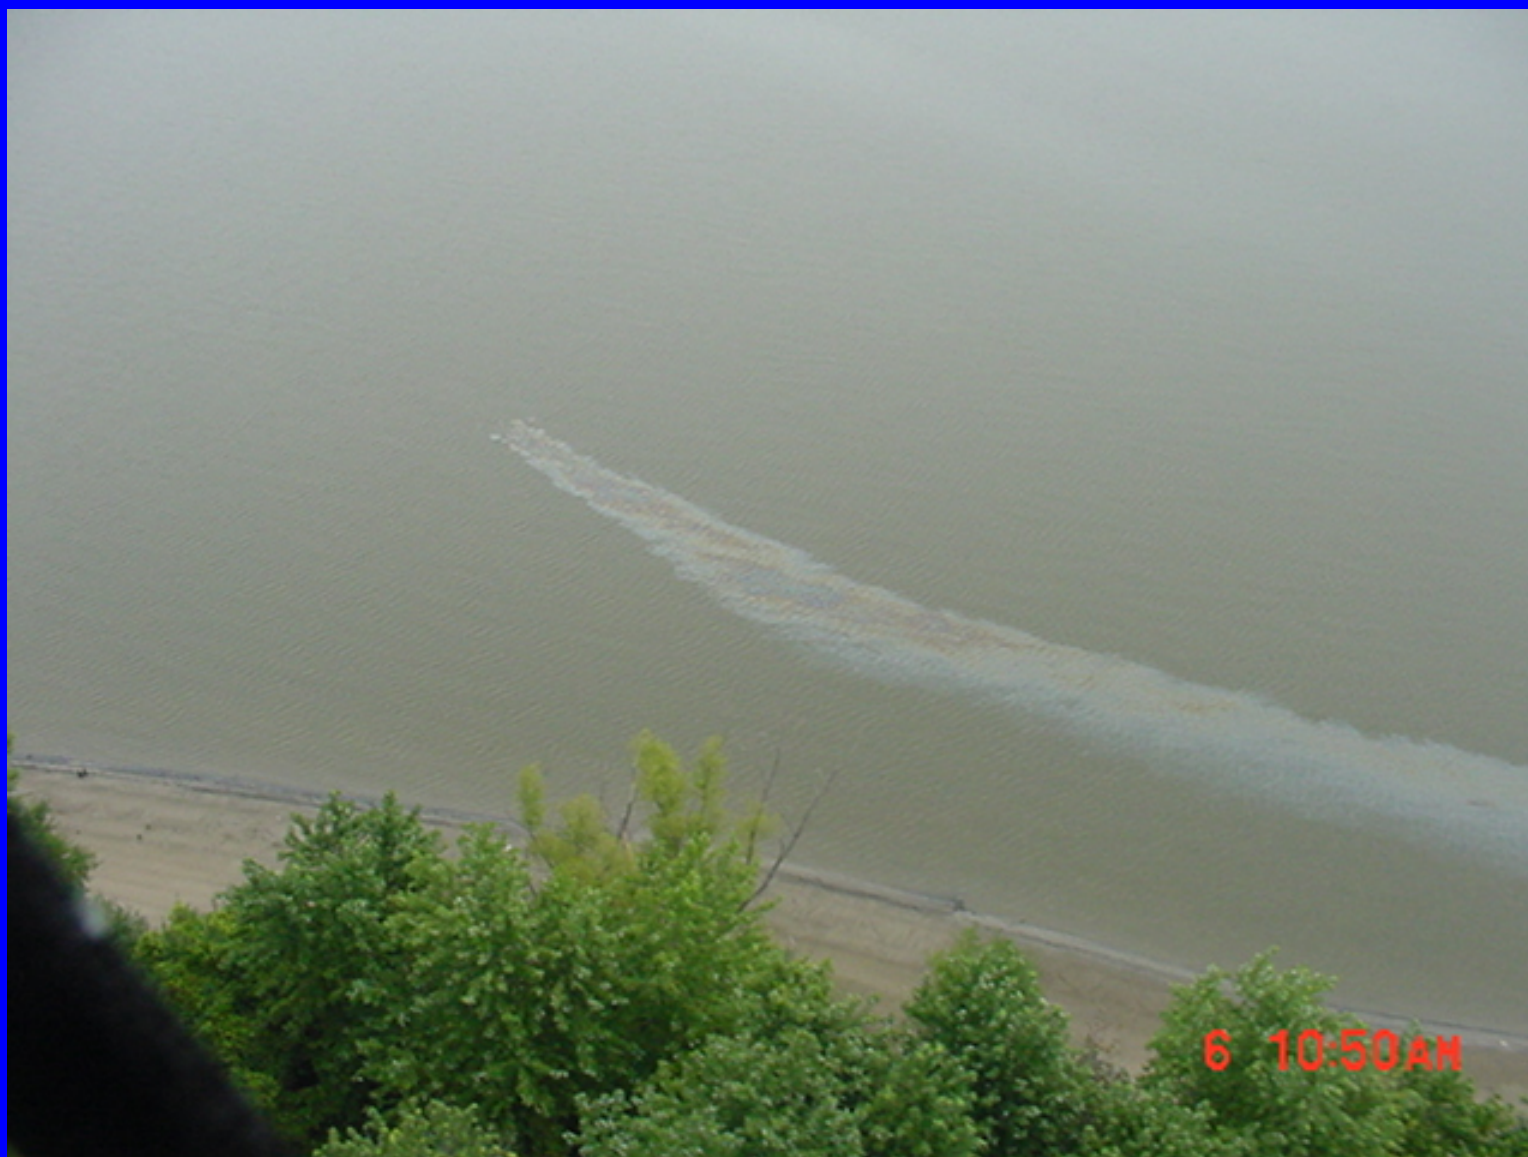
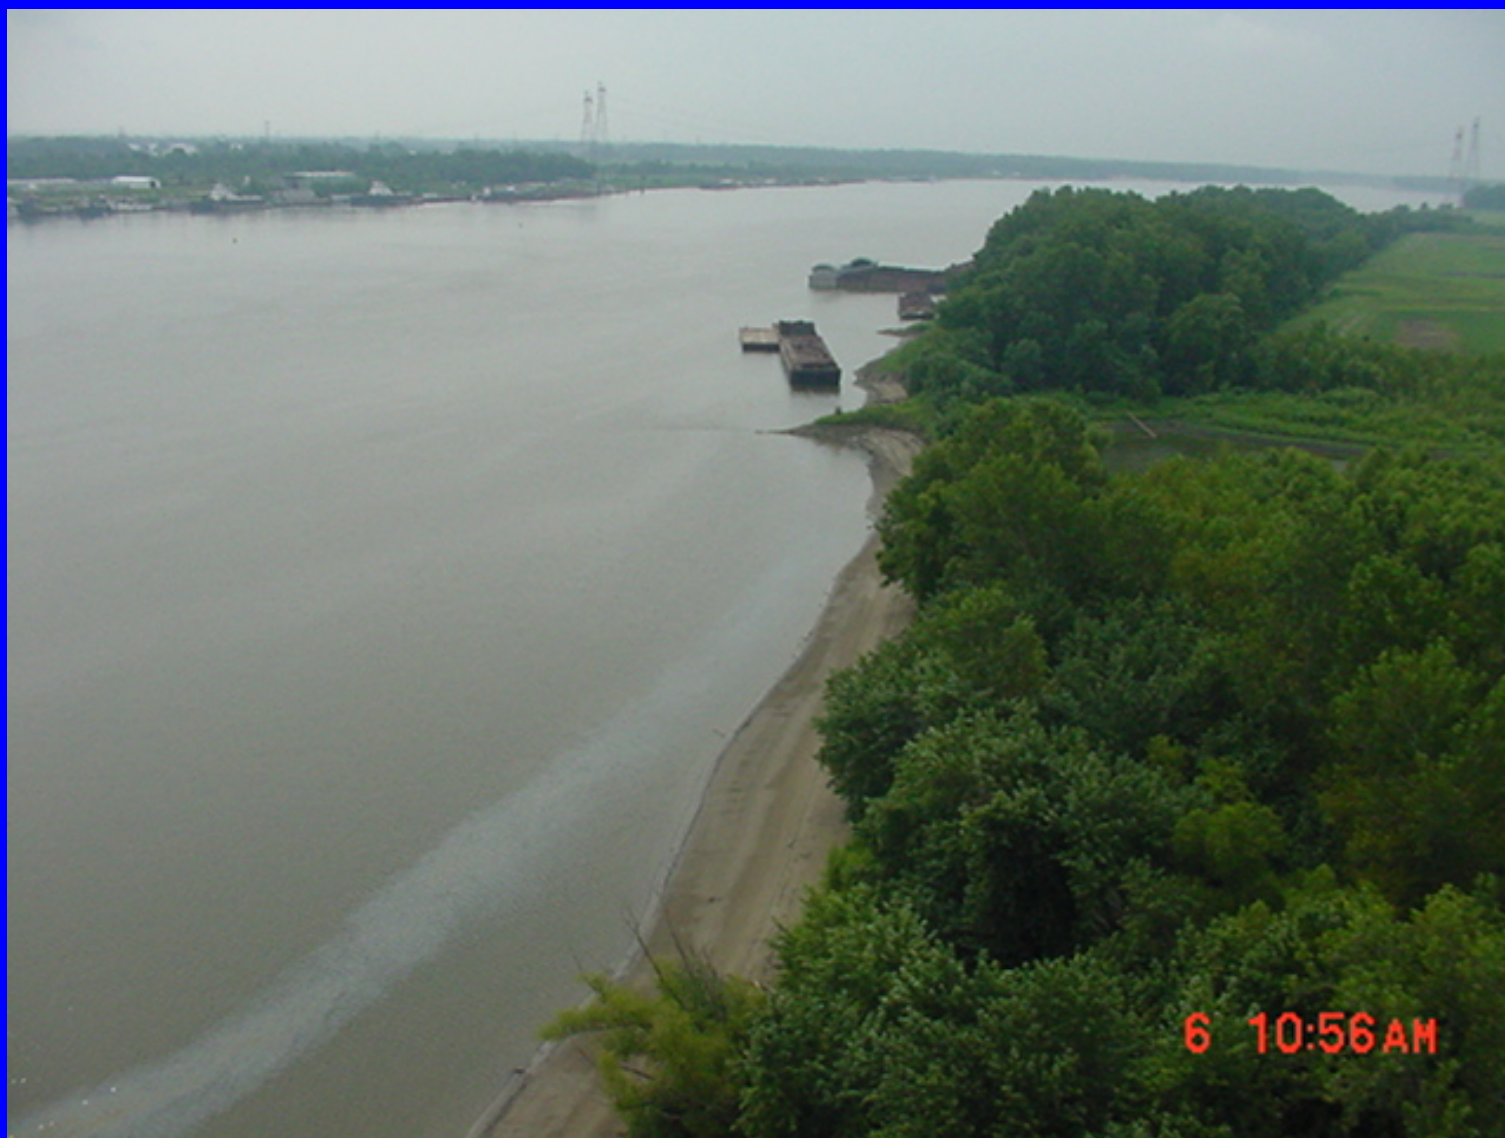
## Crude Oil Sheen from South Line - 8/06/03

- Petroleum sheen reported on August 6, 2003
- Sheen originated approximately 30 yards from the Missouri shoreline in rural St. Charles County
- Source of sheen believed to be one of two ten-inch diameter abandoned crude oil pipelines
- Source located immediately across the river from ConocoPhillips dock in Hartford, Illinois
- Leak source located behind a wing dike, calm water with little current

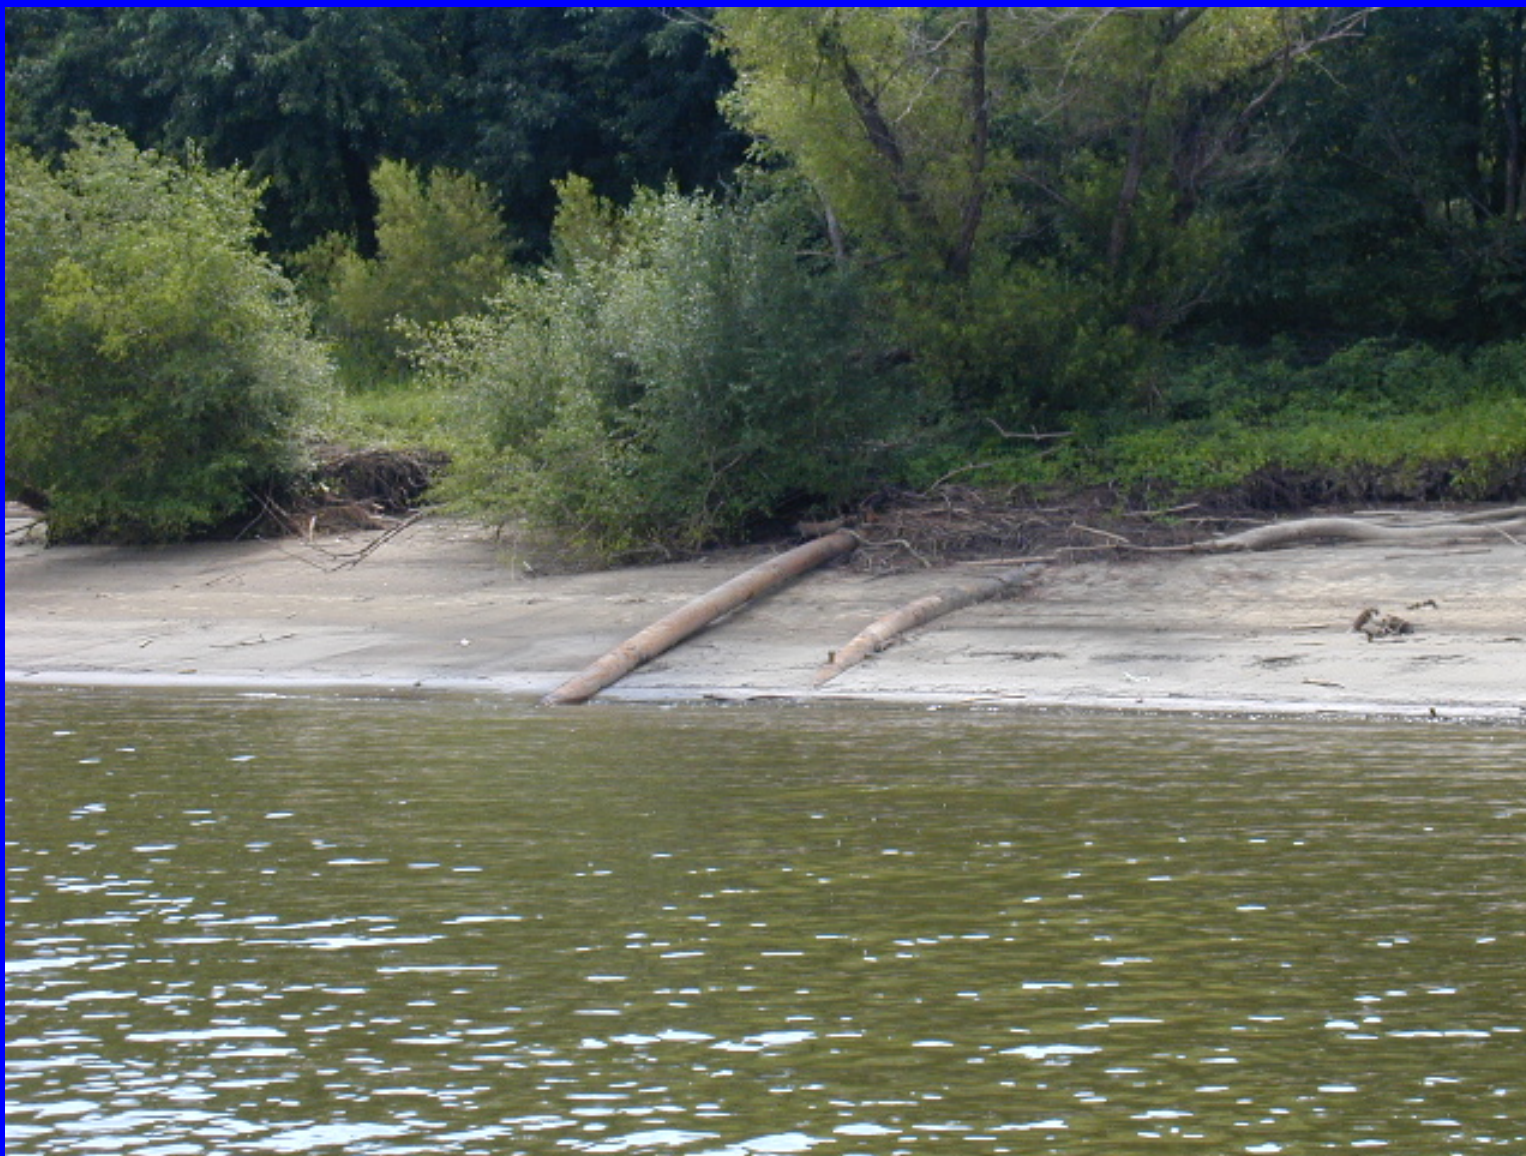
## Abandoned pipelines on Missouri side - 08/06/03

- Pipelines believed to be abandoned in the mid 1940s, although records are incomplete /non-existent
- There were no enforceable abandonment standards until 1980 – 49 CFR 195
- Pipelines are “capped” on both sides of the river.
- Emergency phase focused on mitigating the leak from the south line and containing / recovering the released petroleum.

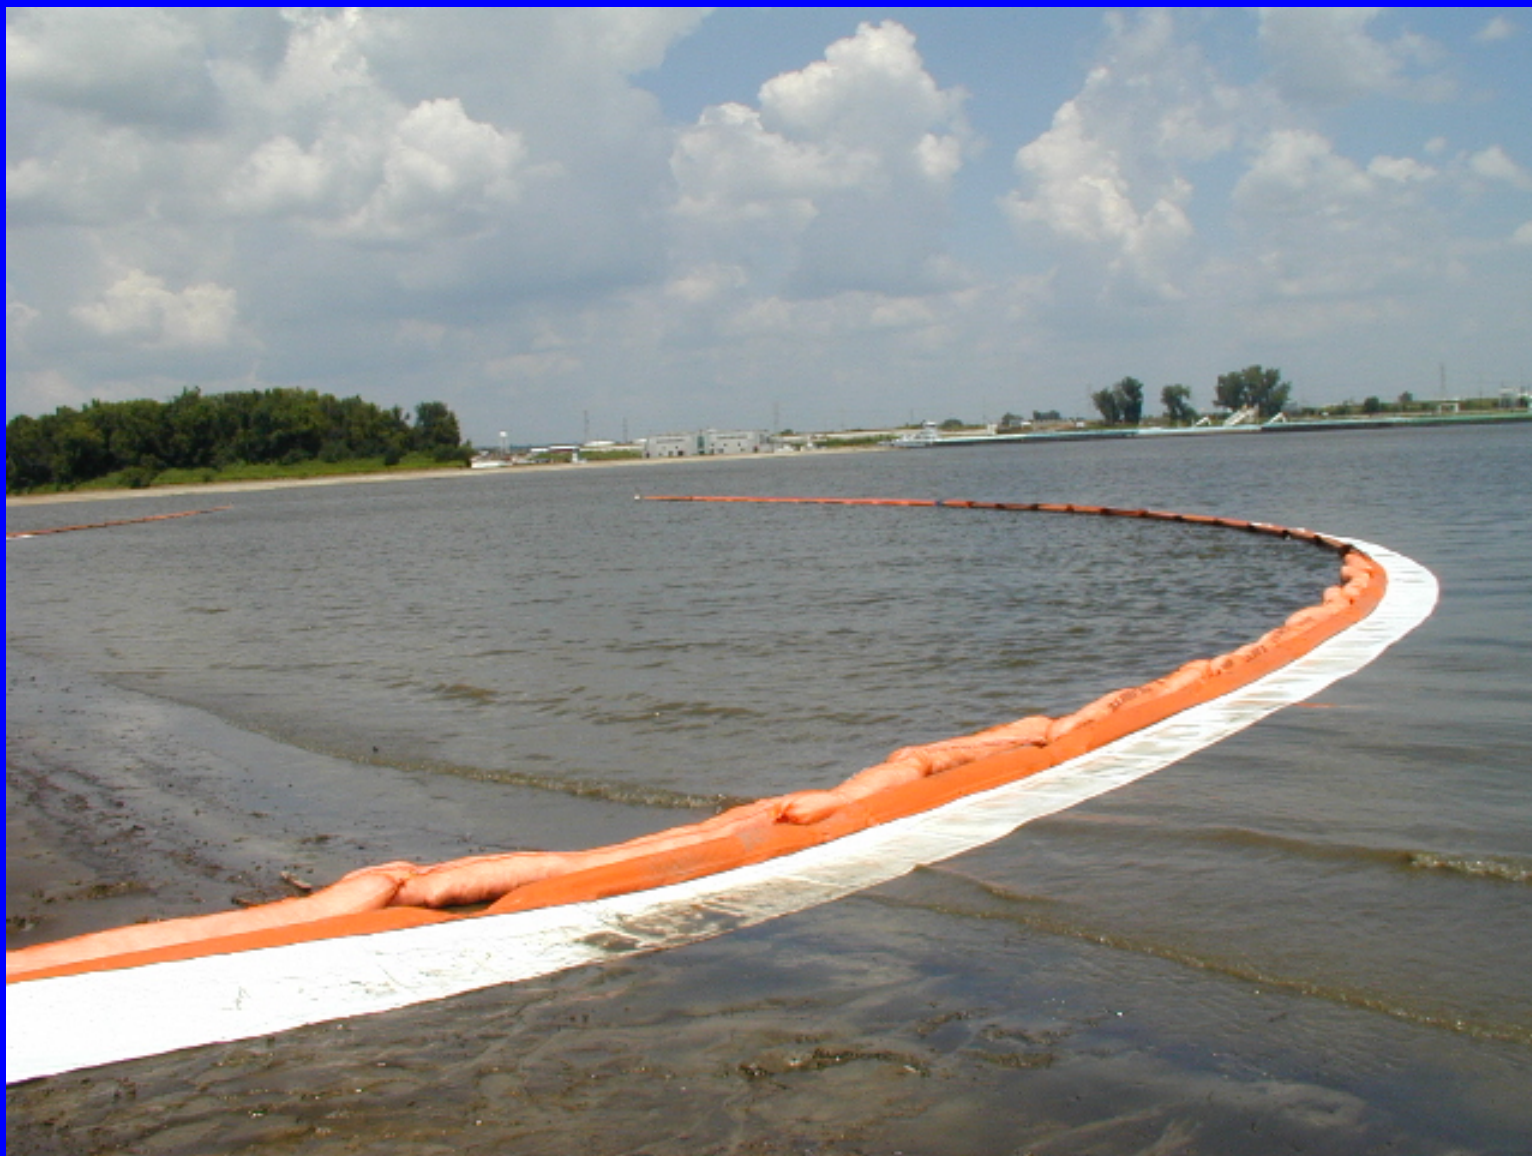
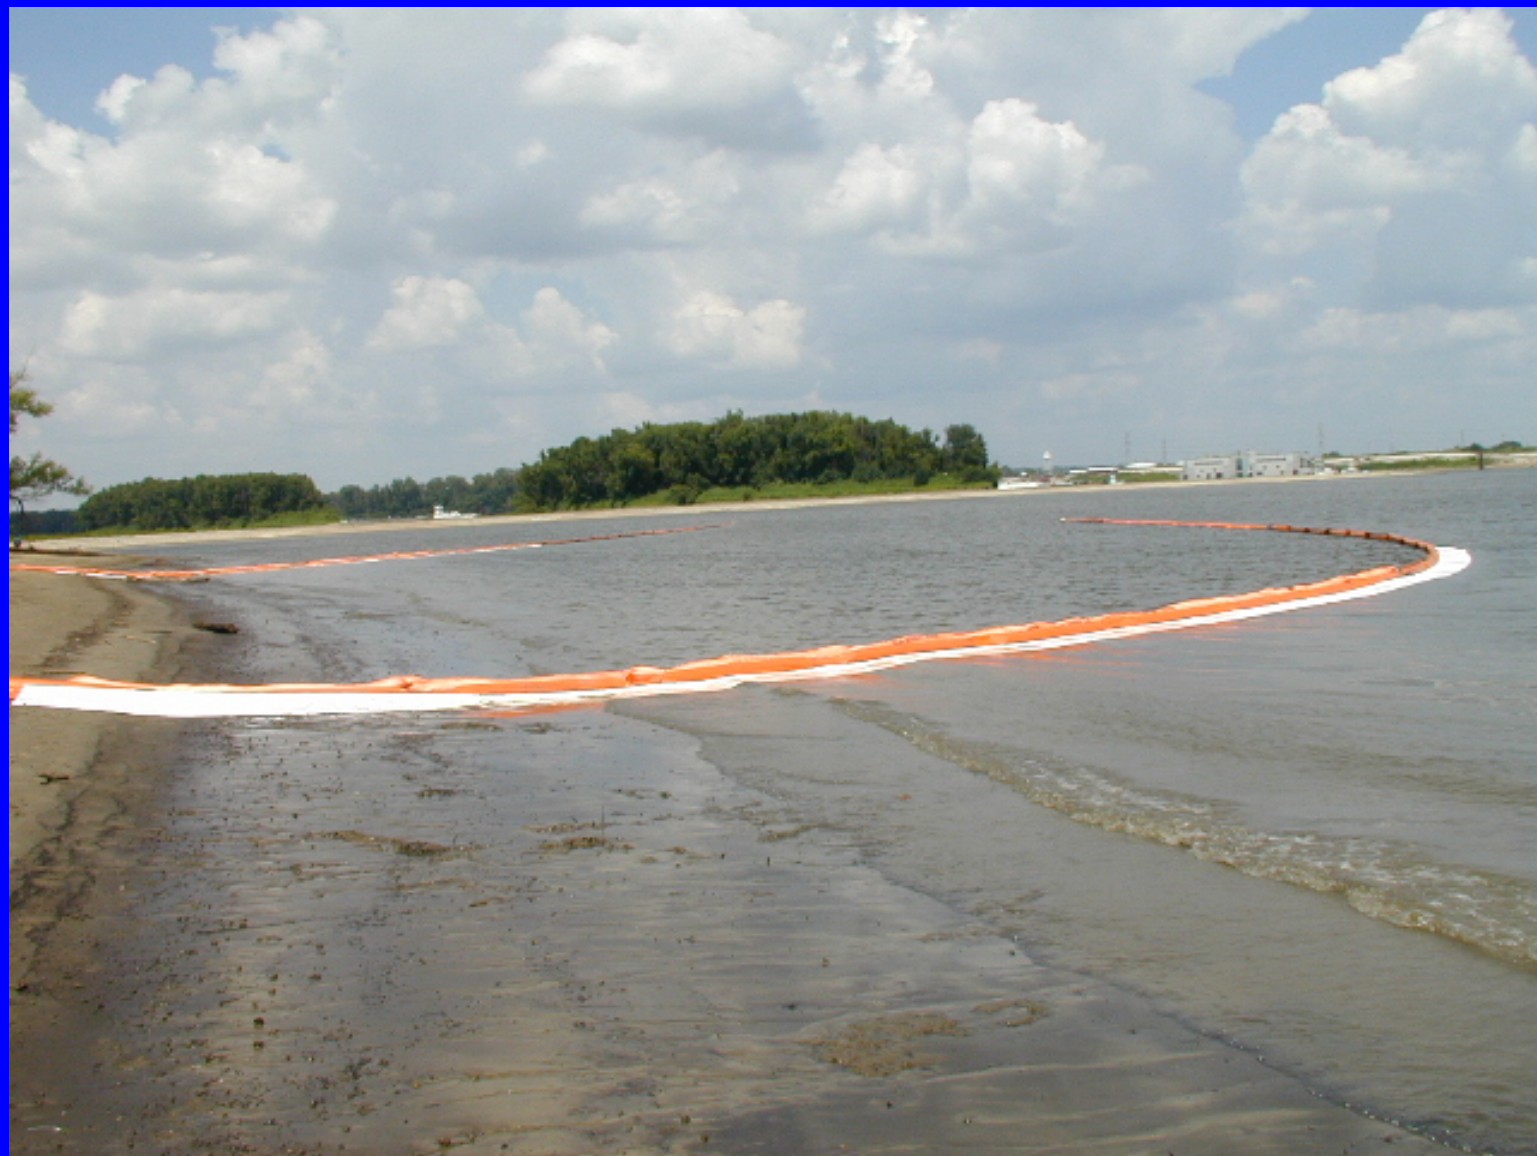
## Initial containment of sheen / release - 08/07/03

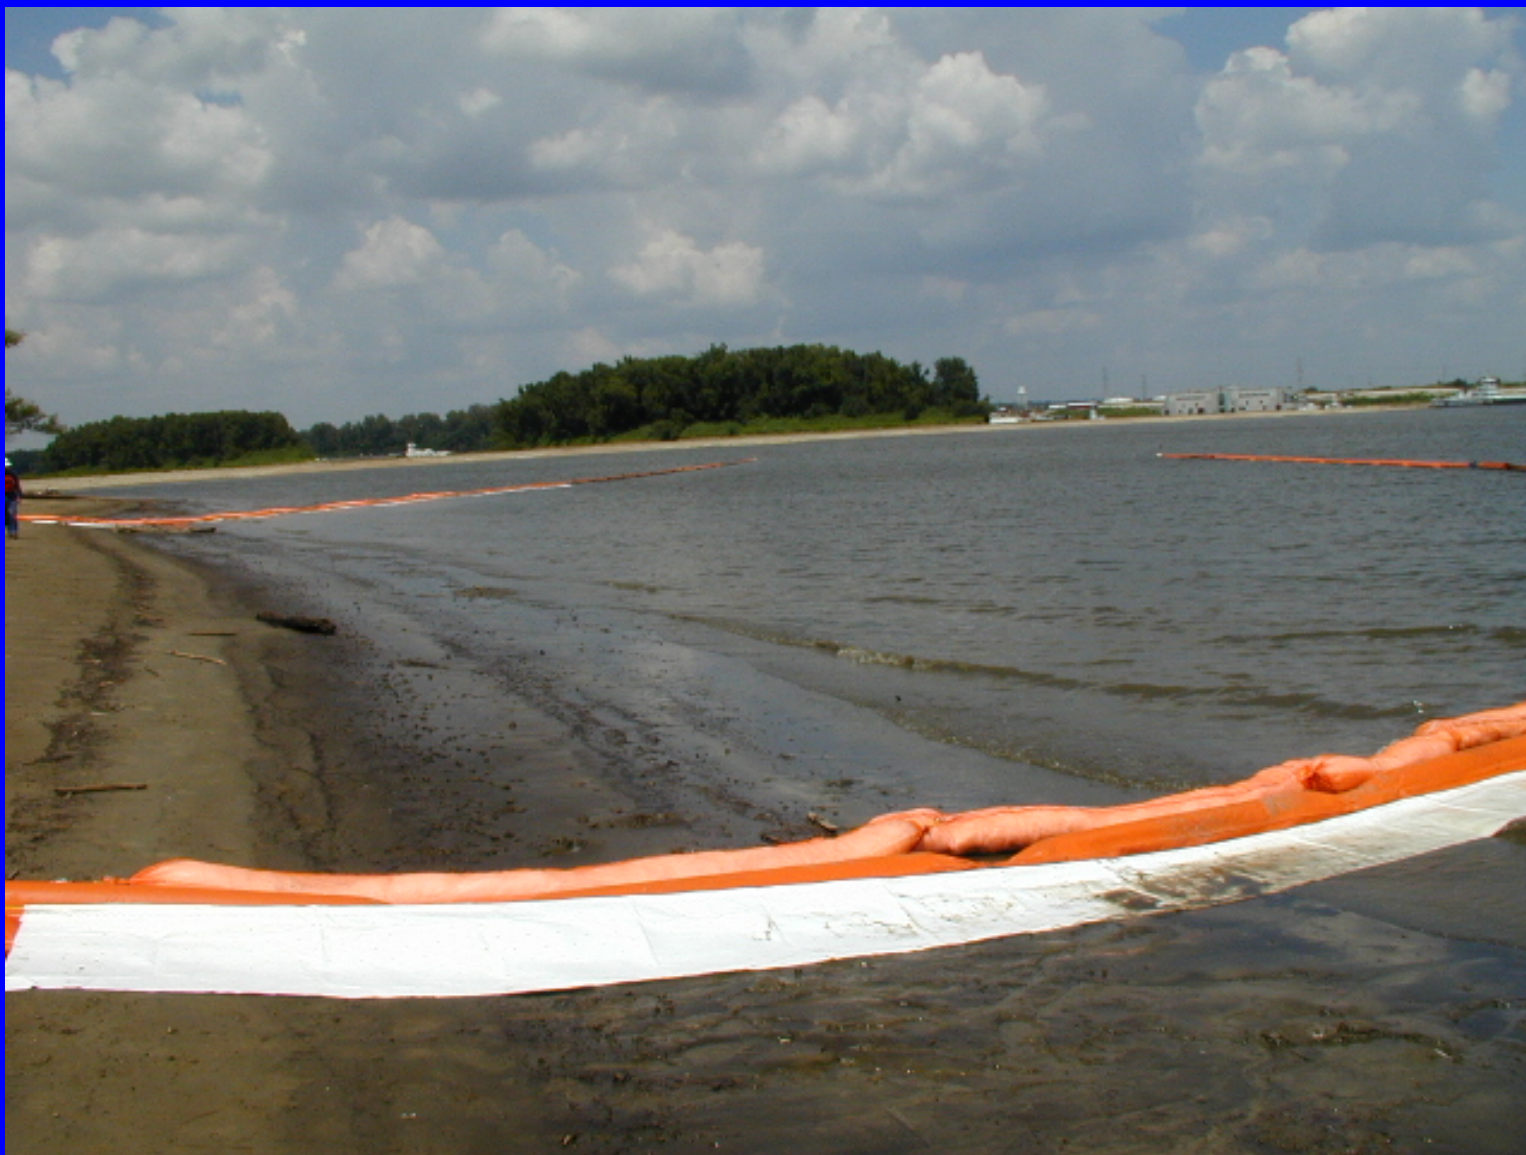
## Containment boom - 08/08/03

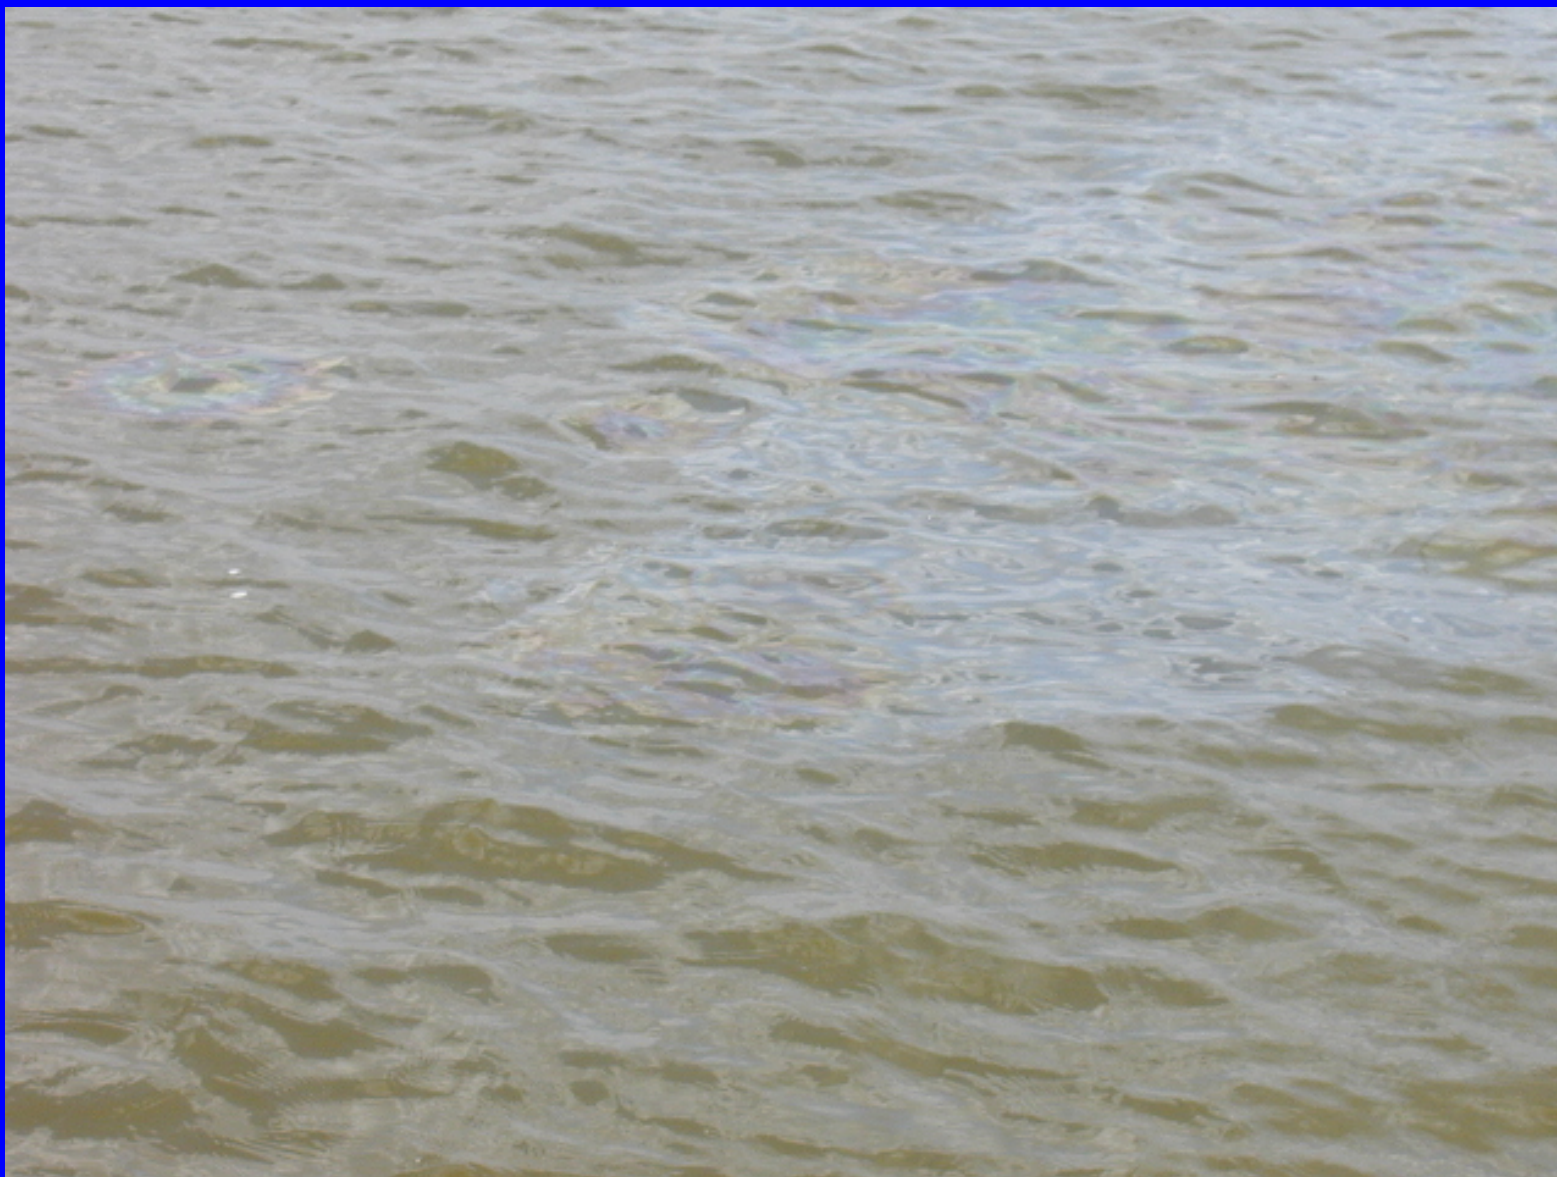
Petroleum sheen at source - 08/06/03

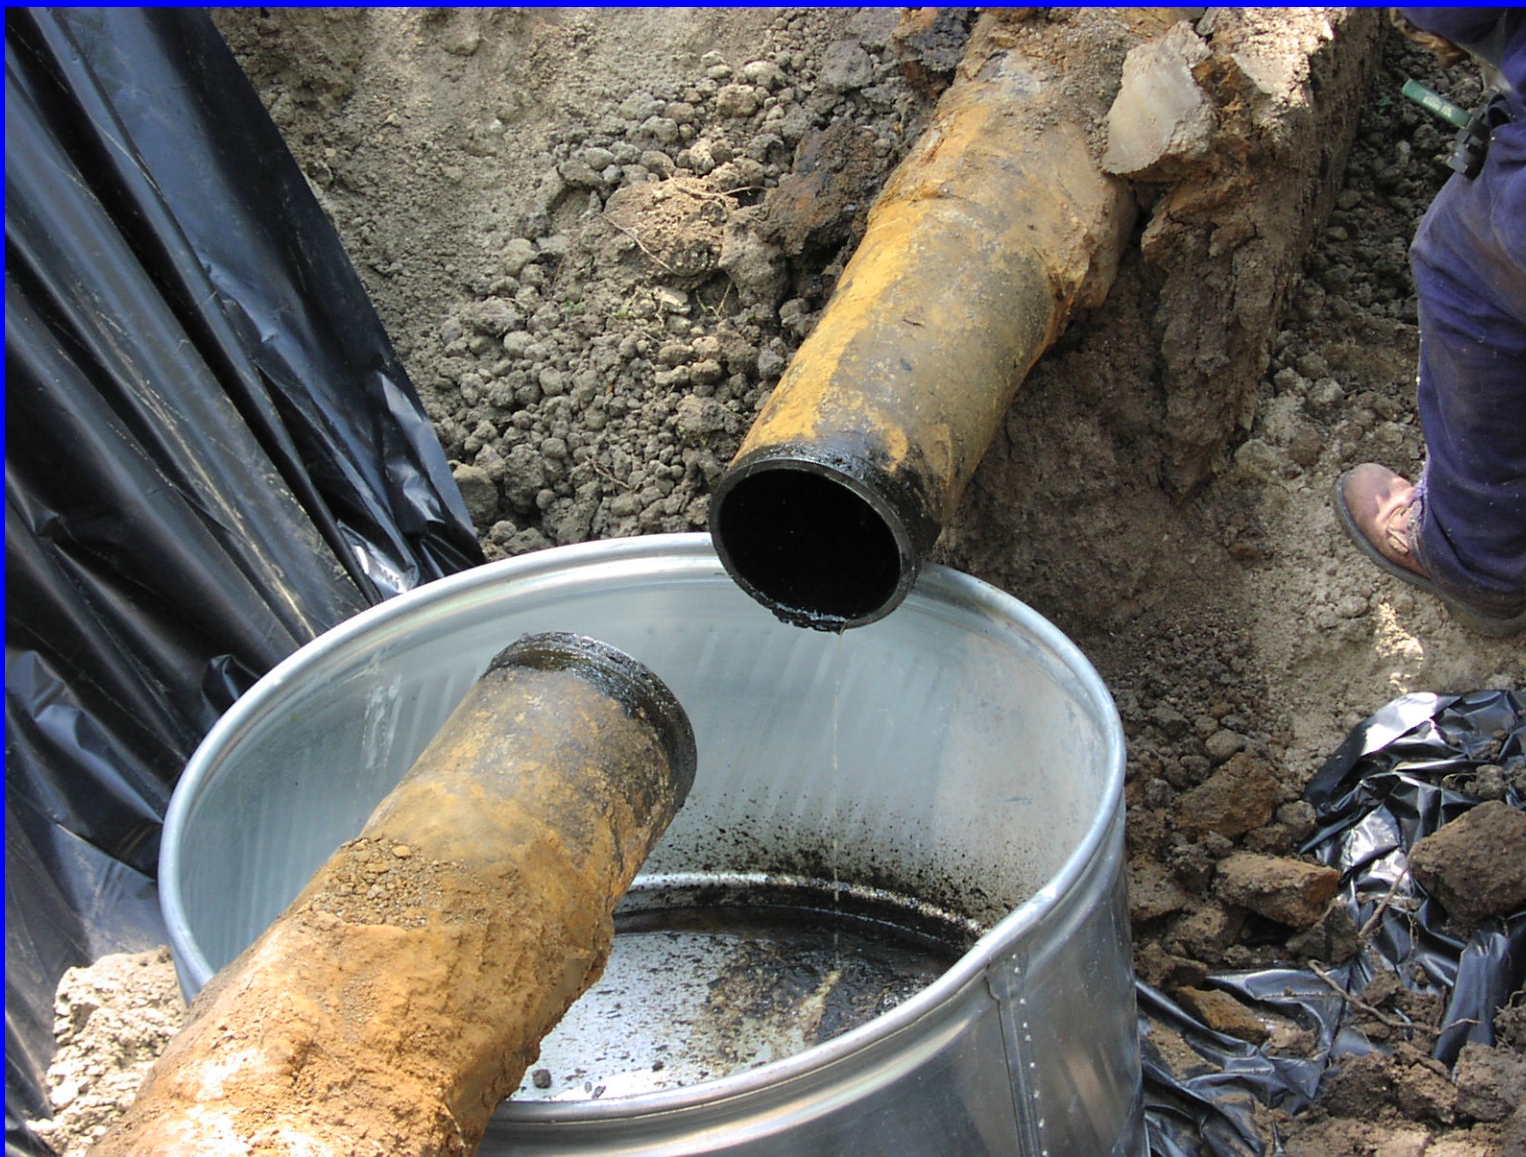
## Cutting of south line - 08/09/03

- The south line was cut open on the Missouri side on 08/09/03 so material could be pumped out of the line.
- 400' section of two inch diameter PVC pipe advanced into the south line to suck out remaining oil/water
- Oil/water mix was pumped into a steel tub at the open end of the pipeline and pumped from there into a trailer mounted vacuum tank
- Approximately 30 barrels of crude and 10 barrels of water were recovered from this operation

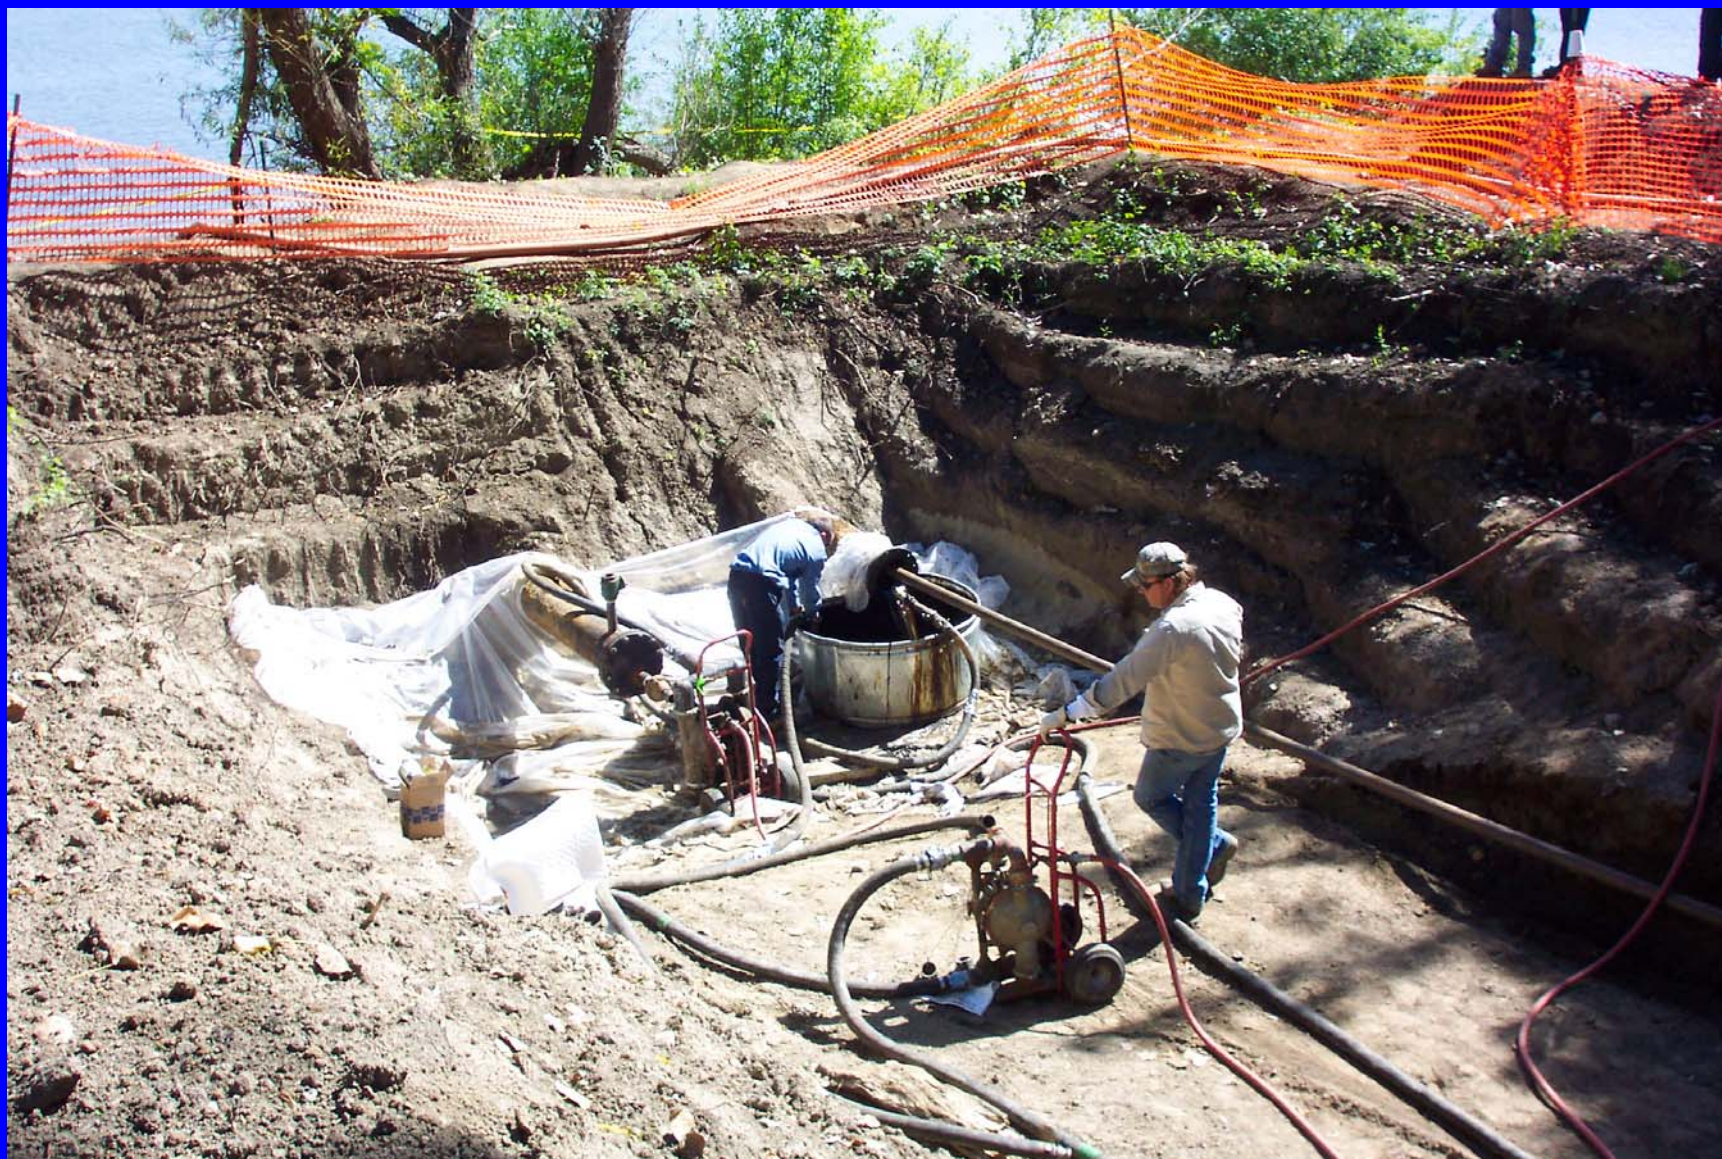
## Pumping out remaining crude/water in South Line

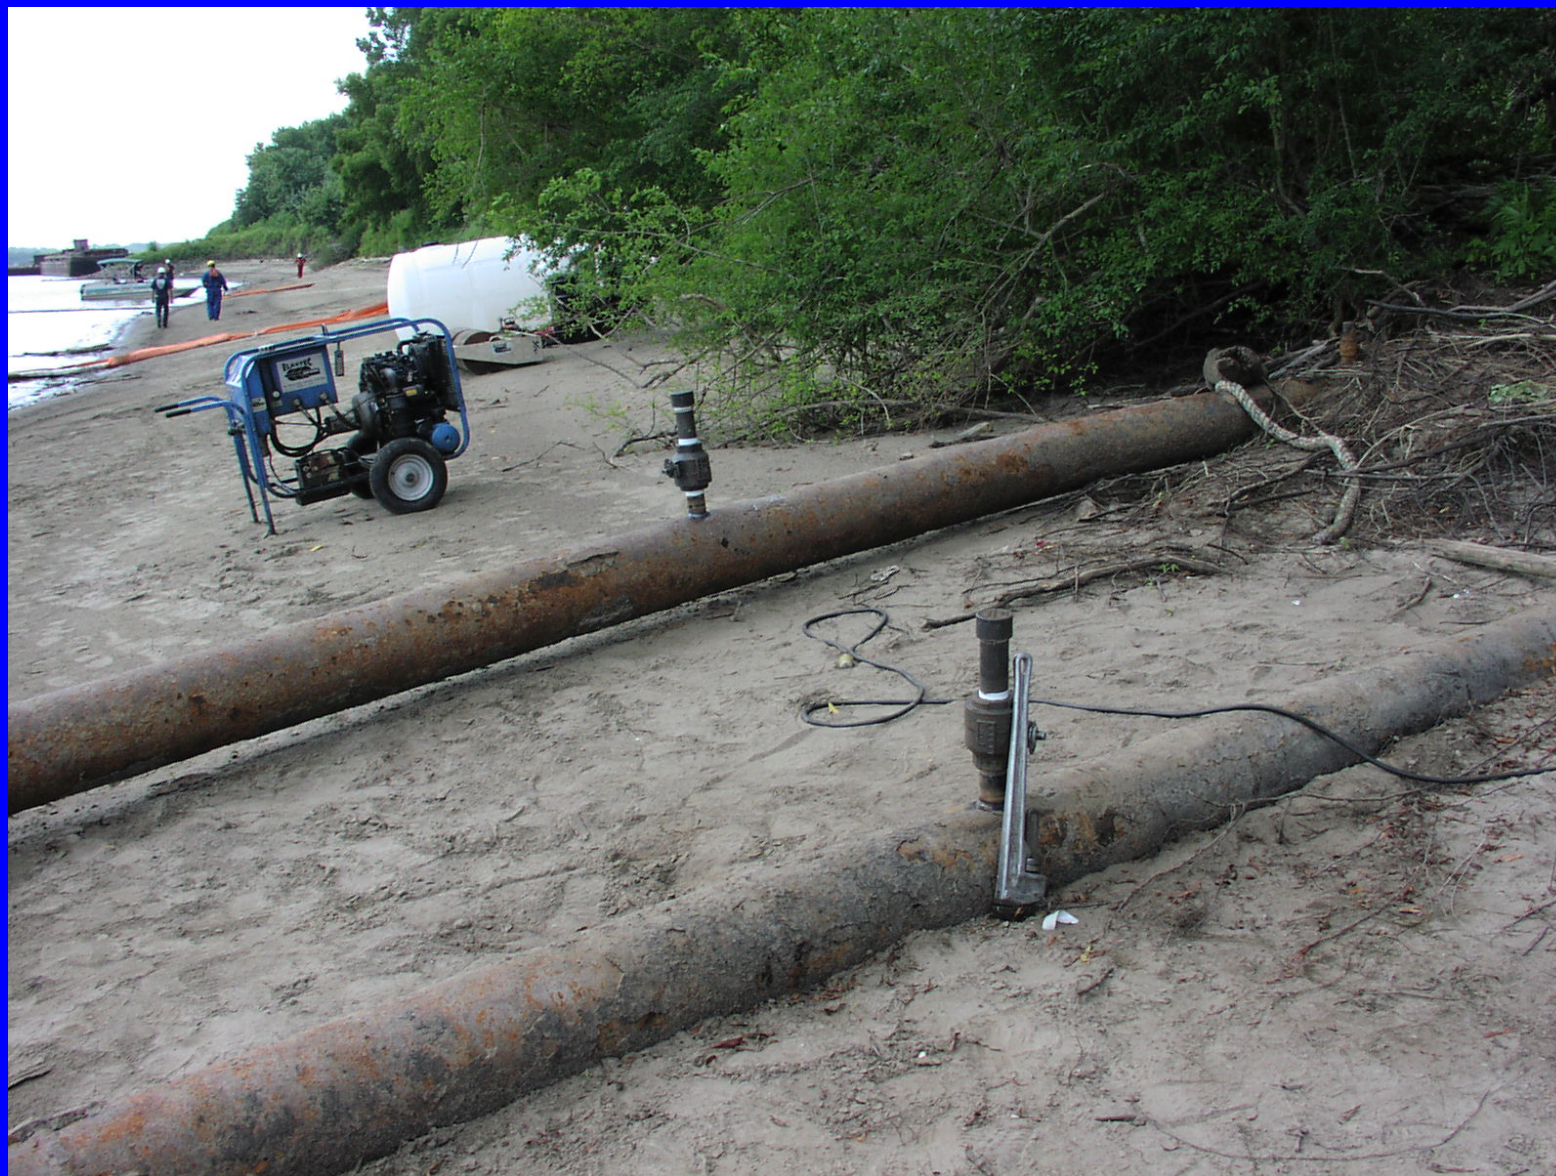
TOR valves installed on lines to bleed off pressure / recover product - 08/08/03

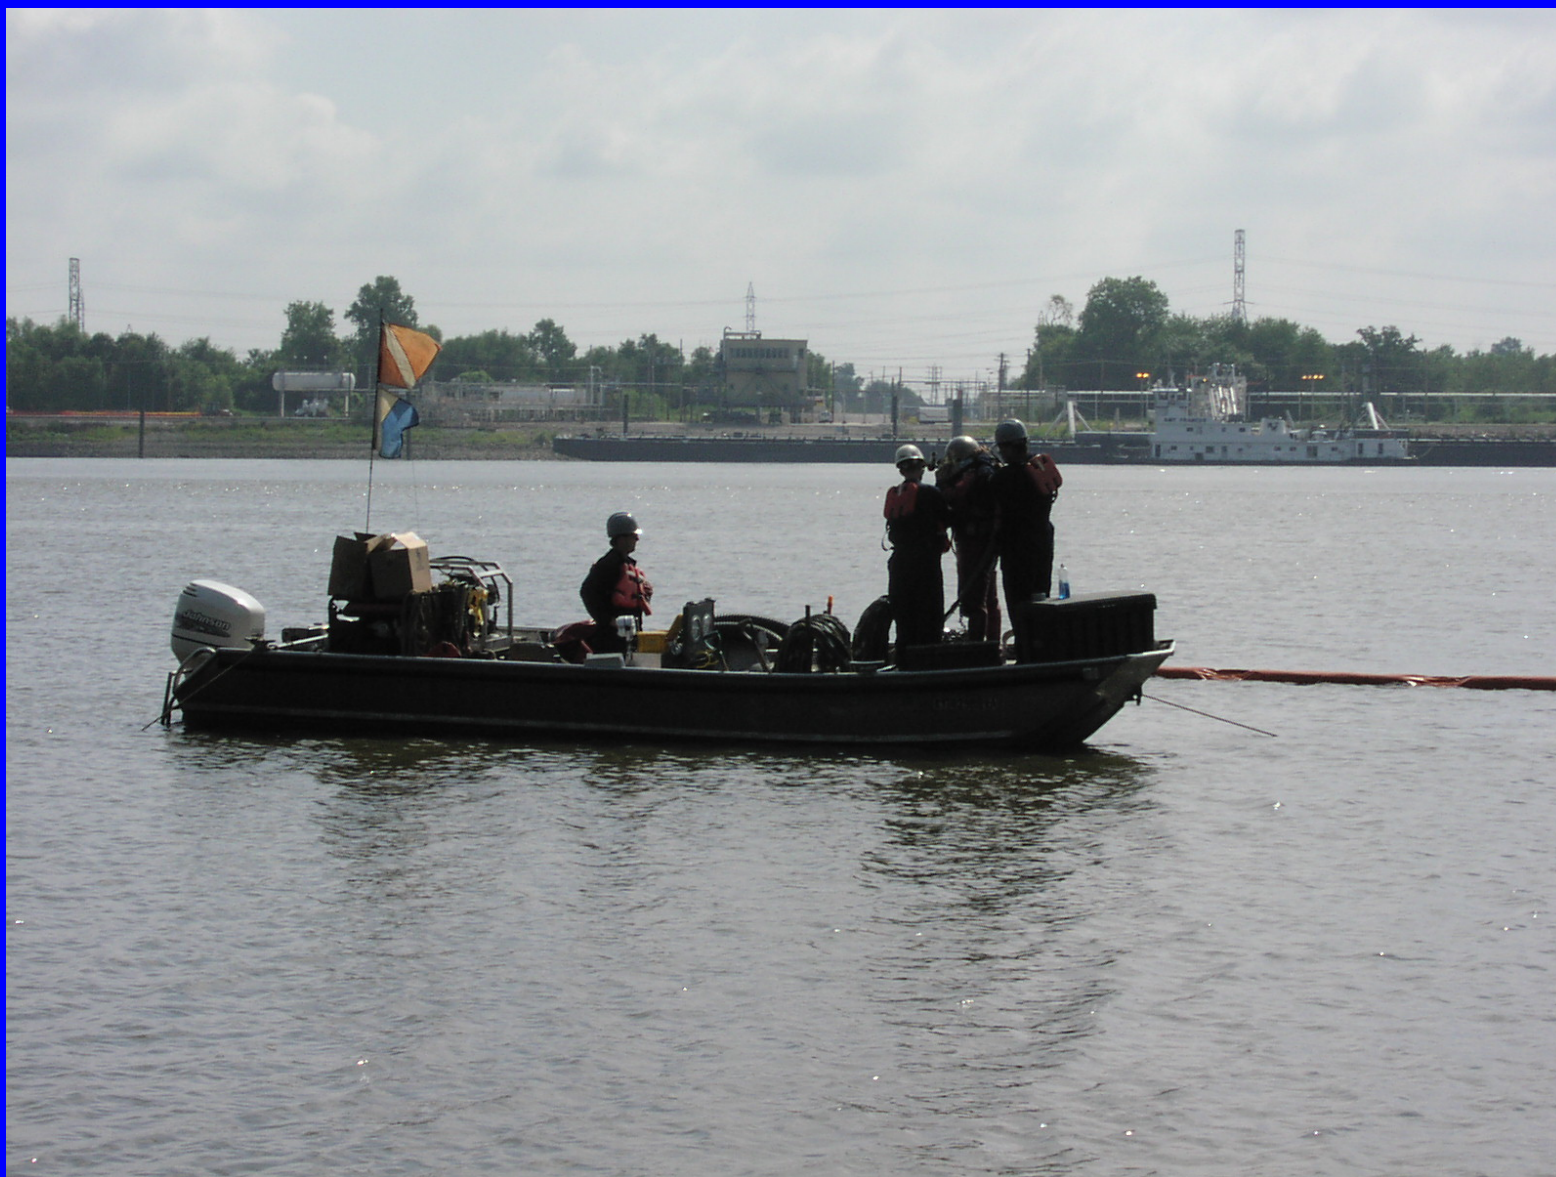
## Dive team at source - 08/09/03

- Dive team hired by ConocoPhillips to find the leak and “patch” the line.
- The dive team found the leak and fastened a “sleeve clamp” to the leak area to stop the leak.
- The dive team disturbed the sediments around the south line causing a release of crude oil.
